# RESEARCH & DEVELOPMENT

### **Risk Assessment of Roadside Utility Structures under Vehicular Impacts**

February 29, 2020

1. Report No. <b>NCDOT 2018-24</b>		2. Government Accession No.		3. Recipient's Catalog No.	
4. Title and Subtitle <b><i>Risk Assessment of Roadside Utility Structures under Vehicular Impacts</i></b>				5. Report Date <b>February 29, 2020</b>

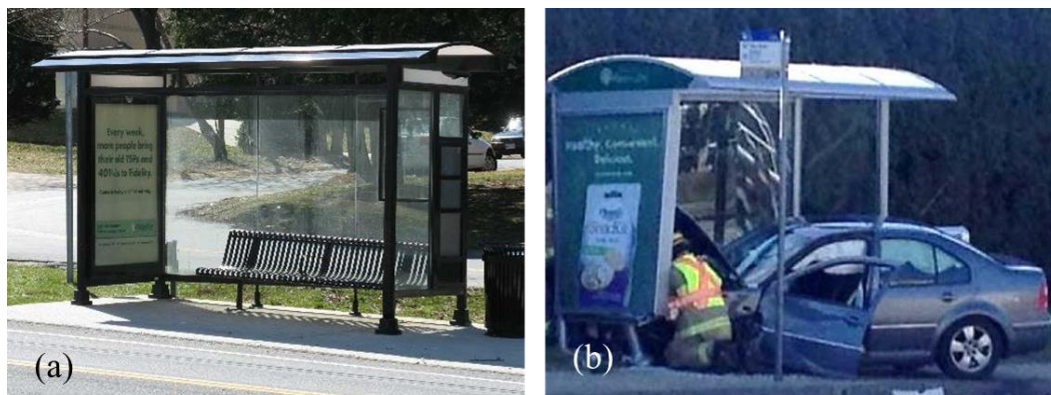
Figure 1.1 A typical bus shelter (a) and a bus shelter crash incident (b).

Figure 1.1(a) shows a typical bus shelter installed on the side of the road along the bus route. The bus shelter is composed of metal frames and polycarbonate coverings. When crashed by the errand vehicles, bus shelters may cause fatality or severe injuries to the occupants as well as pedestrians. Figure 1.1(b) shows a small passenger car crashing into a bus shelter, resulting in the death of the driver due to the relatively high rigidity of the bus shelter. On the other side, a severely damaged bus shelter may also cause severe injuries to the occupants due to intrusions into the occupant compartment. Furthermore, the debris of the shattered polycarbonate glasses imposes safety risks for pedestrians in the proximity of the crash location.

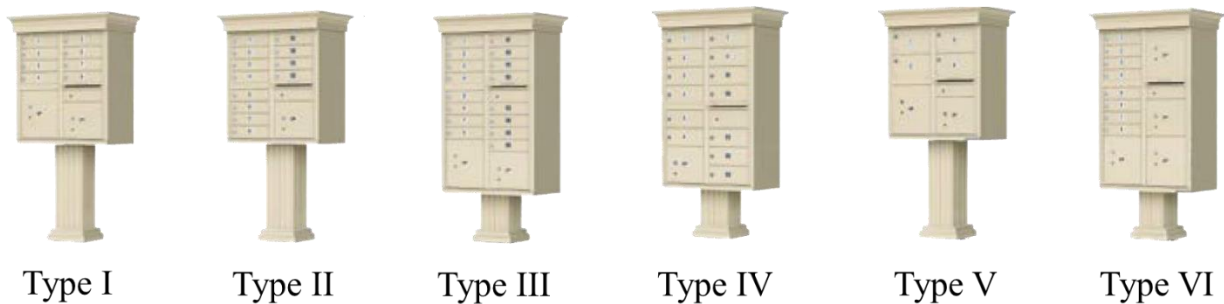
Figure 2.2 Configurations of the six types of cluster mailboxes.

Most of today's CBUs are made by Florence Manufacturing. Table 2.1 gives the detailed specifications of the six types of current models of cluster mailboxes, as shown in Figure 2.2.

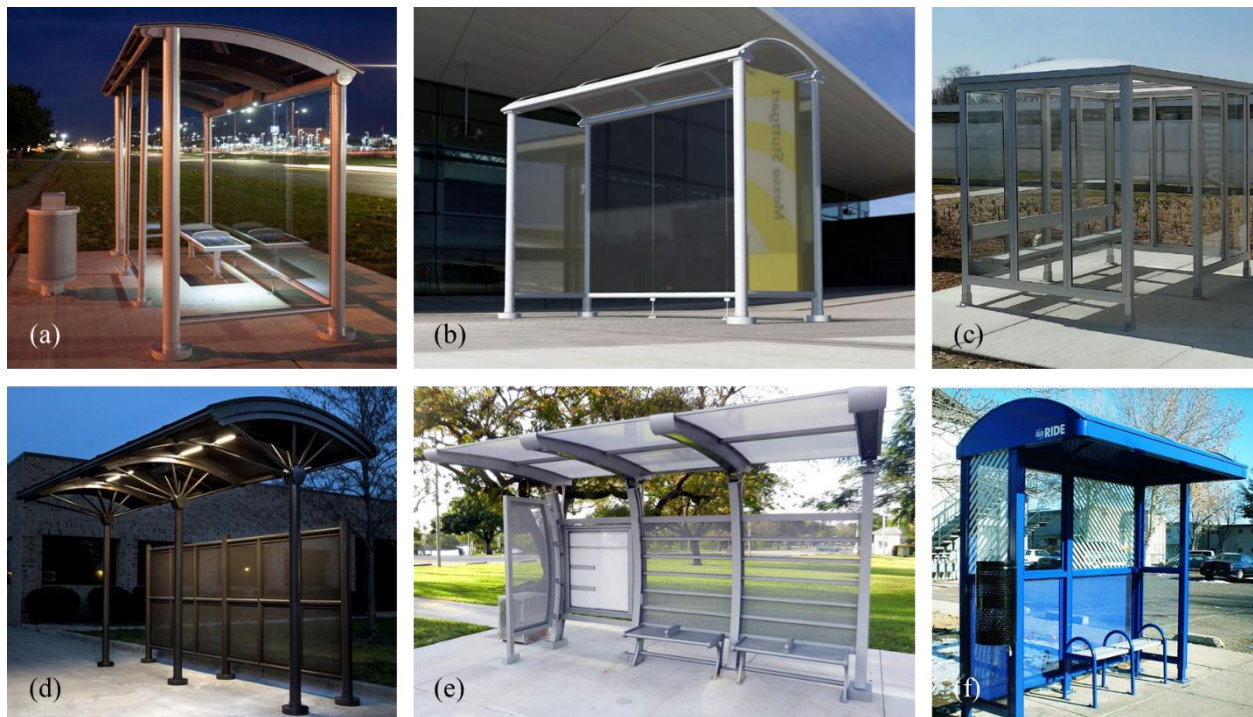
Figure 2.3 Commonly used bus shelter designs in North Carolina.

(a) The Eclipse bus shelter; (b) The Arcade bus shelter; (c) The Dome Slimline bus shelter; (d) The Shade bus shelter; (e) The Interlude bus shelter; and (f) The Techline bus shelter.

Among the bus shelters approved by NCDOT, there are still variations in structural configurations, which might lead to different performance in vehicle crash event. Figure 2.3 shows six popular bus shelters used in North Carolina.

The Eclipse shelter, as seen in Figure 2.3(a), is manufactured by Brasco International and has a dimension of 5×10 ft. The columns are 4.5-inch round tubes, supporting three different type of roof: arc, slope or curved. Three sides of the bus shelter are installed with glass walls as wind screens. The Eclipse bus shelter is typically used in locations with a maximum wind speed of 130 mph (209 km/h) (Brasco 2015).

The Arcade bus shelter called, shown in Figure 2.3(b), was descended from the Eclipse bus shelter with a similar structural configuration and equipped with an integrated gutter system and a strong triangular header support.

The Shade bus shelter (Figure 2.3(d)) distinguishes itself from the other bus shelters with its canopy roof and a single line of three 6-inch round aluminum columns, which significantly improve its structural durability. The Shade bus shelter provides an aluminum windscreen that could withstand winds up to 175 mph (282 km/h).

Figure 2.3(e) shows the Interlude bus shelter that features a cantilever roof with turnbuckle details and is designed to withstand hurricane rated winds up to 175 mph (282 km/h). This bus shelter provides up to 7-ft canopy roof for shade and can be sided with multiple modules to provide a long-span coverage for pedestrians.

Similar to the Interlude bus shelter, the Techline bus shelter as shown in Figure 2.3 (f), features a smooth, curved roof supported by interconnected square aluminum columns. This bus shelter has a dimension ranging from 5×10 ft to 5×15 ft and is designed to withstand winds at a maximum of 100 mph (161 km/h).

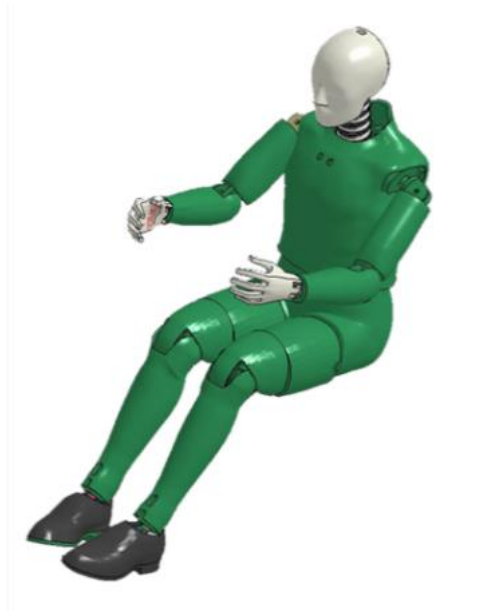
Figure 3.2 The FE model of a Hybrid III 50th percentile crash test dummy.

Figure 3.2 shows the FE model a detailed Hybrid III 50<sup>th</sup> percentile crash test dummy ( $\alpha$  version), which was developed by the Livermore Software Technology Corporation and used in this project. The FE model of the Hybrid III 50<sup>th</sup> percentile crash test dummy had a total of 349 components that were meshed into 228,706 nodes and 338,506 elements (186,808 solid, 151,455 shell, one

discrete, and 242 beam elements) with an overall weight of 176 lb (79.86 kg). Nine material models were used in this dummy model including the elastic model for bones and skull, viscoelastic model for skins, low-density viscous foam model for chest pad, low-density foam model for molded foam, Blatz-Ko rubber model and elastic spring model for some joint connections or supports, and null material model for contact analysis only (i.e., no actual physical properties). Rigid model and viscous foam model were also used in the crash test dummy model.

Accelerometers were defined in the FE model of the Hybrid III 50<sup>th</sup> percentile crash test dummy in the head, chest, spine, belly, pelvis, both knees, and both ankles. These accelerometers were defined using Seatbelt Accelerometer Elements, which could record the time histories of accelerations at locations of potential injury and help to evaluate occupant safety.

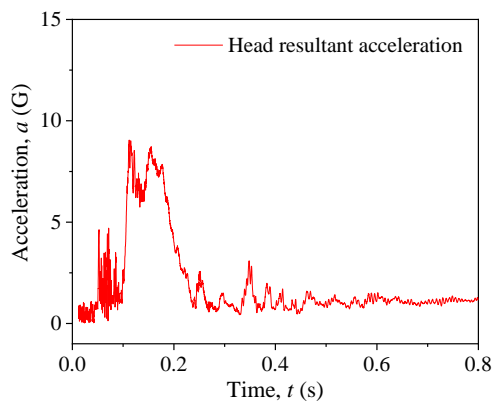
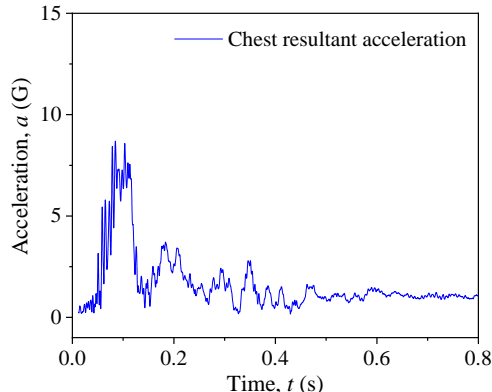
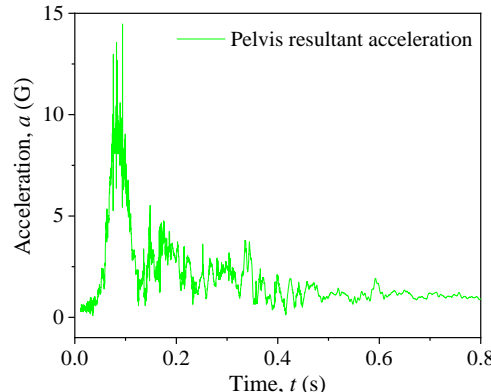
Table 4.2 Dummy responses and injury parameters for Category 1 – Case 1.

Dummy head acceleration		Head impact criteria

Head injury parameter	Value	Threshold	Pass/Fail
		HIC <sub>15</sub>	2.90	700	Pass
		$p(\text{HIC}_{15})$	0 %	31%	Pass
Dummy chest acceleration		Dummy pelvis acceleration

The simulation results of Category 1 – Case 1 showed that the connection joints between the upper mailbox body and the pedestal failed immediately upon impact by the Yaris, triggering the separation and forward ejection of the mailbox upper body. Due to the low clearance of the Yaris, the pedestal was pushed and dragged forward by the vehicle, and eventually failed at the connection with the ground base due to the shear forces from dragging. It was observed that the main structure of upper mailbox body mostly remained intact except for some warping of the slot doors. For occupant response, the dummy's head moved forward and slightly lowered due to the impact pulse, but it did not touch the deployed airbag. The maximum head acceleration was approximately 9 G and the HIC<sub>15</sub> value was calculated to be 2.90, far below the threshold value of 700 and indicating no possibility of skull injury. The trajectory of the mailbox indicated no possibility of hitting the windshield of vehicle, eliminating the possibility of compartment

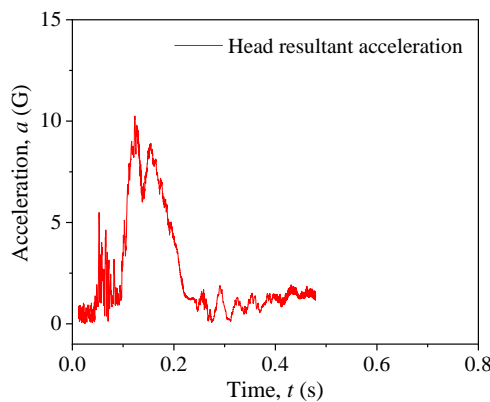
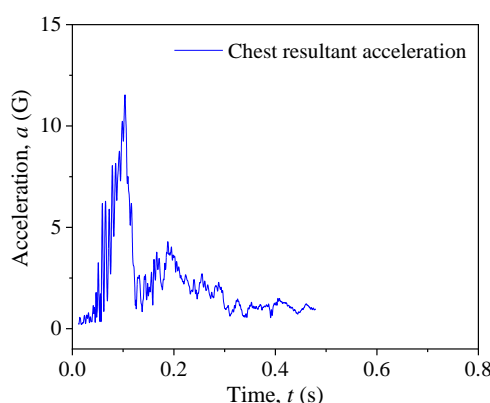
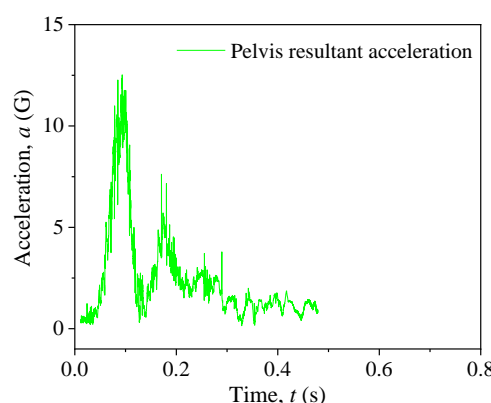
Table 4.4 Dummy responses and injury parameters for Category 1 – Case 2.

Dummy head acceleration	Head impact criteria

Head injury parameter	Value	Threshold	Pass/Fail
	HIC <sub>15</sub>	3.72	700	Pass
	$p(\text{HIC}_{15})$	0 %	31%	Pass
Dummy chest acceleration	Dummy pelvis acceleration

The simulation results of Category 1 – Case 2 showed that the vehicular and occupant responses were similar to those for Category 1 – Case 1. In case 2, however, the mailbox upper body and the pedestal remained connected and were pushed forward by the test vehicle. The trajectory of the mailbox showed that it would not hit the windshield of vehicle and there was no possibility of compartment intrusions. The vehicle's roll and pitch angles, as well as the OIVs and ORAs in both longitudinal and lateral directions, were all within the MASH allowed limits. The maximum head acceleration of the crash test dummy was approximately 10 G and the HIC<sub>15</sub> value was calculated to be 3.72, far below the threshold value of 700 and indicating no possibility of skull injury. The above analysis indicated that there was no potential occupant injury for this impact case.

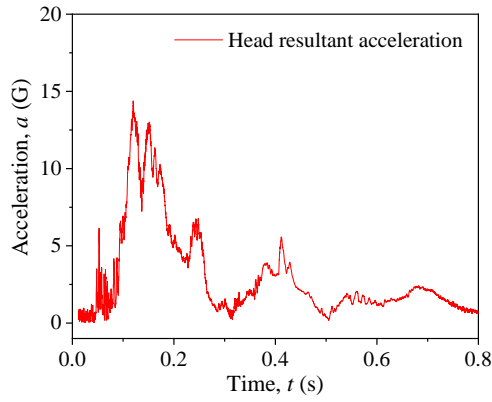
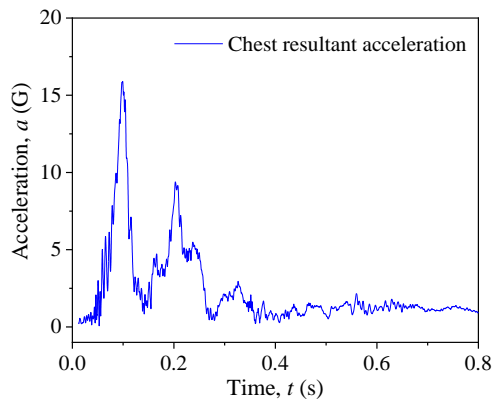
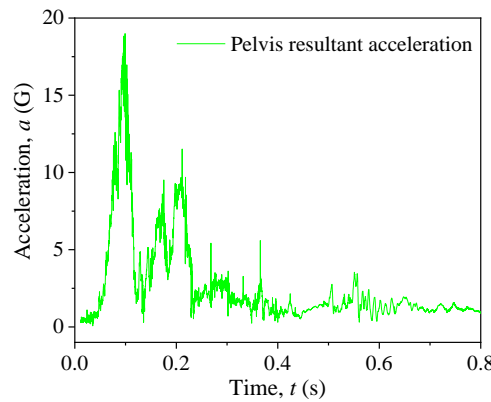
Table 4.6 Dummy responses and injury parameters for Category 1 – Case 3.

Dummy head acceleration		Head impact criteria

Head injury parameter	Value	Threshold	Pass/Fail	
	HIC <sub>15</sub>	9.02	700	Pass	
	$p(\text{HIC}_{15})$	0 %	31%	Pass	
Dummy chest acceleration		Dummy pelvis acceleration

The simulation results of Category 1 – Case 3 showed that the connection between the pedestal and upper body of the unit being impacted first did not fail completely due to support from the other mailbox unit. Subsequently, the pedestals of the two mailbox units stuck between the front wheels and the two units were pushed forward, causing severe warpage and wrinkling on the vehicle's hood. Compared to the single-unit mailbox, the dual-unit mailbox caused larger deformation on the impacting vehicle. Nevertheless, the trajectory of the mailbox indicated no possibility of hitting the windshield of vehicle, eliminating the possibility of compartment intrusions. The vehicle's roll and pitch angles, as well as the OIVs and ORAs in both longitudinal and lateral directions, were all within the MASH allowed limits. For occupant response, the maximum head acceleration was approximately 14 G and the HIC<sub>15</sub> value was calculated to be

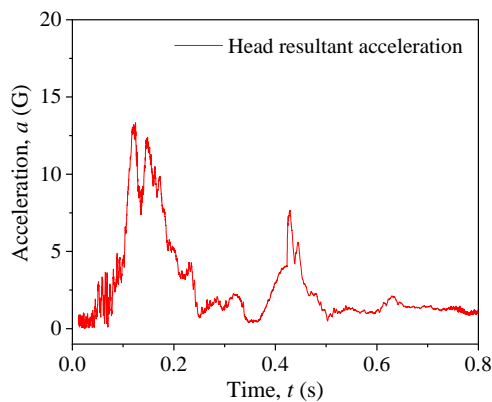
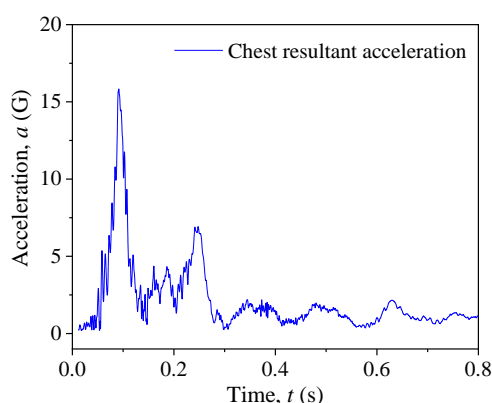
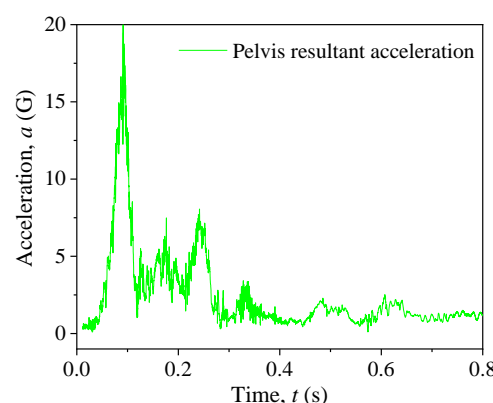
Table 4.8 Dummy responses and injury parameters for Category 1 – Case 4.

Dummy head acceleration		Head impact criteria

Head injury parameter	Value	Threshold	Pass/Fail	
	HIC <sub>15</sub>	7.64	700	Pass	
	$p(\text{HIC}_{15})$	0 %	31%	Pass	
Dummy chest acceleration		Dummy pelvis acceleration

The simulation results of Category 1 – Case 4 showed that both units were knocked off the ground and the connection between the pedestal and upper body of the unit being impacted first failed while the pedestal and upper body of the second unit stay connected. Due to the 25° impact angle and interactions between the two units, the first unit was pushed to the driver side of the vehicle while the second unit was pushed forward. The trajectory of the mailbox indicated no possibility of hitting the windshield of vehicle, eliminating the possibility of compartment intrusions. The vehicle's roll and pitch angles, as well as the OIVs and ORAs in both longitudinal and lateral directions, were all within the MASH allowed limits. For occupant responses, the dummy's head moved forward and touched the deployed airbag. The maximum head acceleration was approximately 13 G and the HIC<sub>15</sub> value was calculated to be 7.64, far below the threshold value of 700 and indicating no possibility of skull injury. The above analysis indicated that there was no potential occupant injury for this impact case.

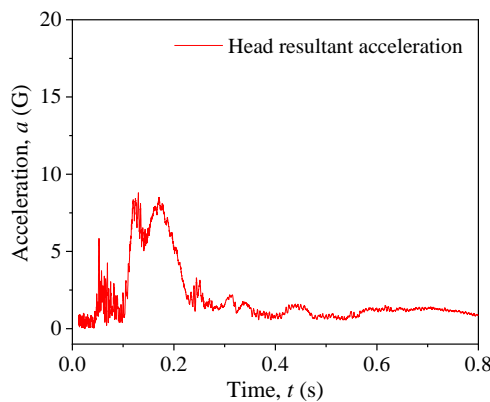
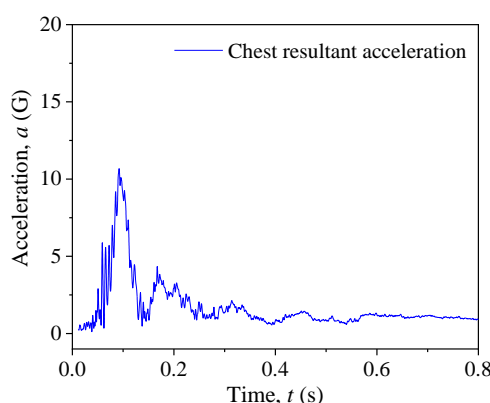
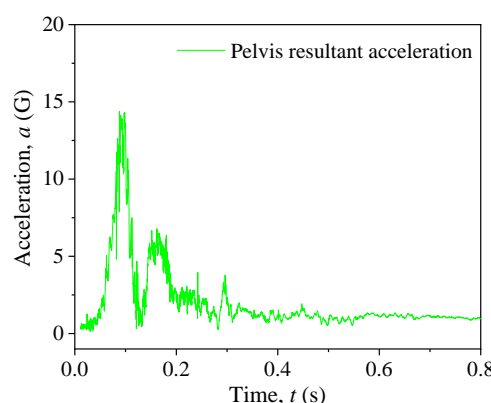
Table 4.10 Dummy responses and injury parameters for Category 1 – Case 5.

Dummy head acceleration	Head impact criteria

Head injury parameter	Value	Threshold	Pass/Fail
	HIC <sub>15</sub>	2.65	700	Pass
	<i>p</i> (HIC <sub>15</sub> )	0 %	31%	Pass
Dummy chest acceleration	Dummy pelvis acceleration

The simulation results of Category 1 – Case 5 showed that the vehicle had only minor scratches on the hood upon impacting the first mailbox unit, and the hood was popped open upon impacting the second unit. There was no severe damage for the test vehicle after the impact. The first mailbox unit remained in place while the second unit was detached from the ground and pushed forward by the striking vehicle. The trajectory of the mailbox showed that there was no possibility of hitting the windshield of vehicle, eliminating the possibility of compartment intrusions. The vehicle's roll and pitch angles, as well as the OIVs and ORAs in both longitudinal and lateral directions, were all within the MASH allowed limits. During the impact, the dummy's head moved forward and slightly touched the deployed airbag. The maximum head acceleration was approximately 8 G and the  $HIC_{15}$  value was calculated to be 2.65, far below the threshold value of 700 and indicating no possibility of skull injury. The above analysis indicated that there was no potential occupant injury for this impact case. The OIV, ORA and  $HIC_{15}$  were all similar to those of the single-unit Type I mailbox impacted by the Toyota Yaris at 25° impact angle. It was also observed that the impact severity of Category 1 – Case 5, i.e., the dual-unit Type I mailbox impacted at the mid-point, was slightly less severe than Category 1 – Case 4, i.e., the same mailbox impacted at the corner.

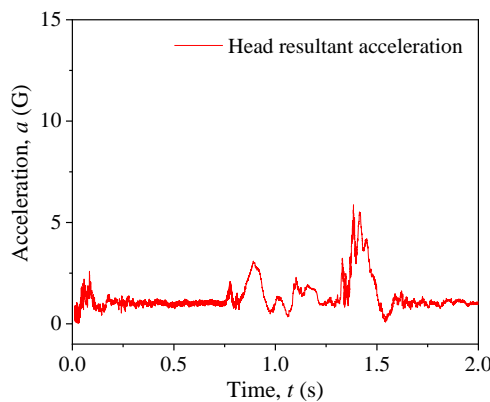
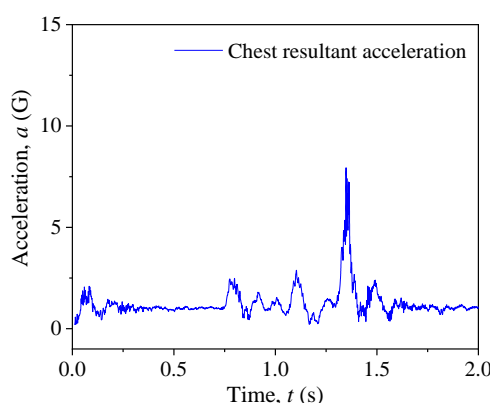
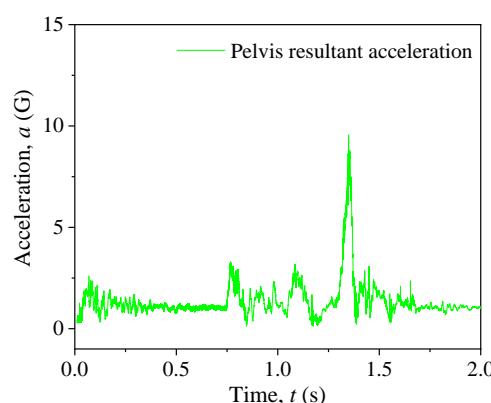
Table 4.12 Dummy responses and injury parameters for Category 1 – Case 6.

Dummy head acceleration		Head impact criteria

Head injury parameter	Value	Threshold	Pass/Fail
		HIC <sub>15</sub>	0.91	700	Pass
		$p(\text{HIC}_{15})$	0 %	31%	Pass
Dummy chest acceleration		Dummy pelvis acceleration

The simulation results of Category 1 – Case 6 were similar to those of Category 1 – Case 2 in which the same mailbox was placed on a flat road without curb. The connection between the pedestal and the upper body did not fail and the mailbox was pushed forward by the test vehicle. The test vehicle had only minor damages around the front passenger-side light. The trajectory of the mailbox showed that there was no possibility of hitting the windshield of vehicle, eliminating the possibility of compartment intrusions. The vehicle's roll and pitch angles, as well as the OIVs and ORAs in both longitudinal and lateral directions, were all within the MASH allowed limits. It was observed that the dummy swung laterally when the vehicle passed the curb with four wheels contacting the curb at different time. This can be seen from the several peaks in the head, chest, and pelvis accelerations. During impact, the dummy's head moved forward and slightly lowered due to the impact pulse, but it did not touch the deployed airbag. The maximum head acceleration was approximately 6 G and the HIC<sub>15</sub> value was calculated to be 0.91, far below the threshold value of 700 and indicating no possibility of skull injury. The above analysis indicated that there was no potential occupant injury for this impact case.

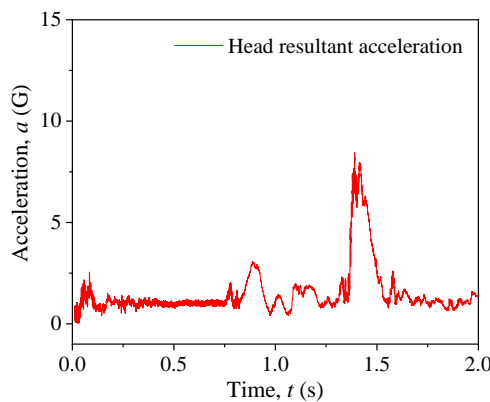
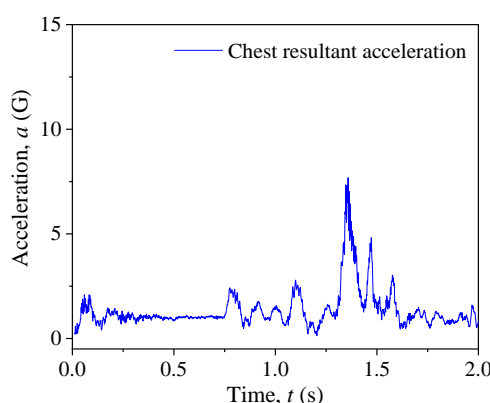
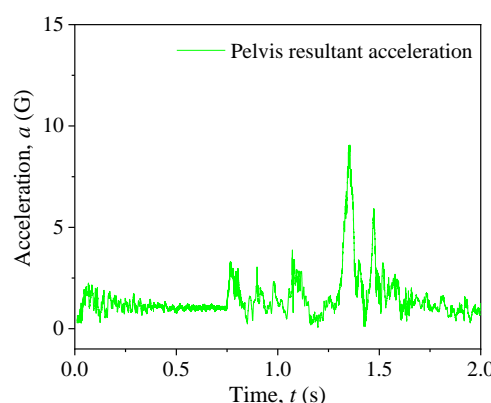
Table 4.14 Dummy responses and injury parameters for Category 1 – Case 7.

Dummy head acceleration	Head impact criteria

Head injury parameter	Value	Threshold	Pass/Fail
	HIC <sub>15</sub>	2.37	700	Pass
	$p(\text{HIC}_{15})$	0 %	31%	Pass
Dummy chest acceleration	Dummy pelvis acceleration

The simulation results of Category 1 – Case 7 showed that the two mailbox units were pushed forward together by the striking vehicle. The pedestals and upper bodies remained connected, reducing the chance of the pedestals intruding into the occupant compartment from underneath. The vehicles damage was mainly on the hood. The trajectory of the mailbox showed no possibility of hitting the windshield of vehicle, eliminating the possibility of compartment intrusions. The vehicle's roll and pitch angles were larger than those of the previous case but were well below the MASH limits. The OIVs and ORAs in both longitudinal and lateral directions were all within the MASH allowed limits. For occupant response, the dummy's head moved forward and slightly lowered due to the impact pulse, but it did not touch the deployed airbag. The maximum head acceleration was approximately 7.5 G and the HIC<sub>15</sub> value was calculated to be 2.37, far below the threshold value of 700 and indicating no possibility of skull injury. The above analysis indicated that there was no potential occupant injury for this impact case.

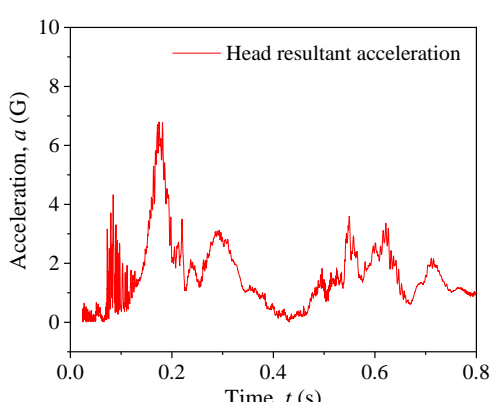
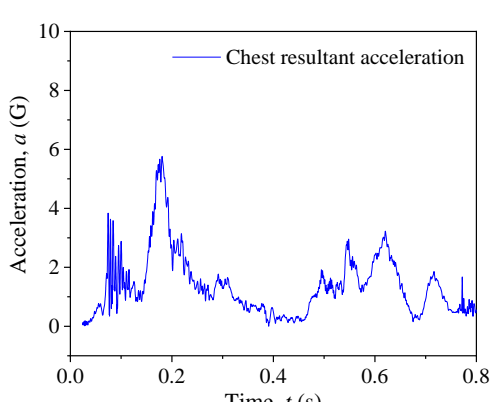
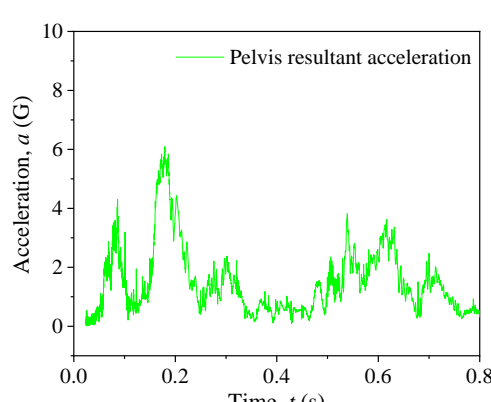
Table 4.18 Vehicle trajectory during impact for Category 2 – Case 1.

Dummy head acceleration		Head impact criteria

Head injury parameter	Value	Threshold	Pass/Fail
		HIC <sub>15</sub>	1.38	700	Pass
		<i>p</i> (HIC <sub>15</sub> )	0 %	31%	Pass
Dummy chest acceleration		Dummy pelvis acceleration

The simulation results of Category 2 – Case 1 showed that the connection between pedestal and upper body failed when impacted by the Ford F250. The pedestal stuck under the vehicle's chassis and the upper unit was pushed forward by the vehicle. The trajectory of the mailbox showed that there was no possibility hitting the windshield of vehicle, eliminating the possibility of compartment intrusions. The damage to the test vehicle was minimal with only a shallow dent on the hood. The vehicle's roll and pitch angles, as well as the OIVs and ORAs in both longitudinal and lateral directions, were all within the MASH allowed limits. For occupant response, the dummy's head did not have significant movement and thus did not touch the deployed airbag. The maximum head acceleration was approximately 7 G, 2 G lower than the same impact condition with a Toyota Yaris. The HIC<sub>15</sub> value was calculated to be 1.38, far below the threshold value of 700 and indicating no possibility of skull injury. The above analysis indicated that there was no potential occupant injury for this impact case.

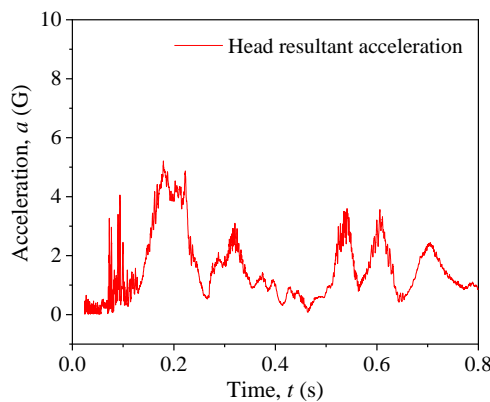
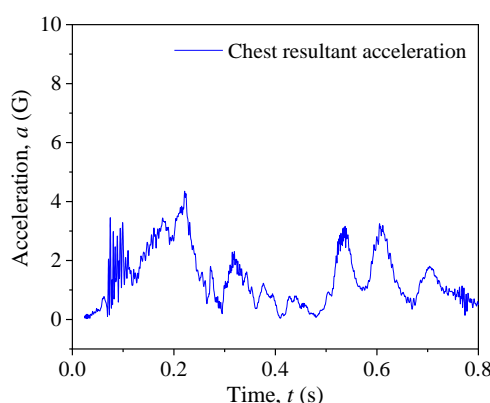
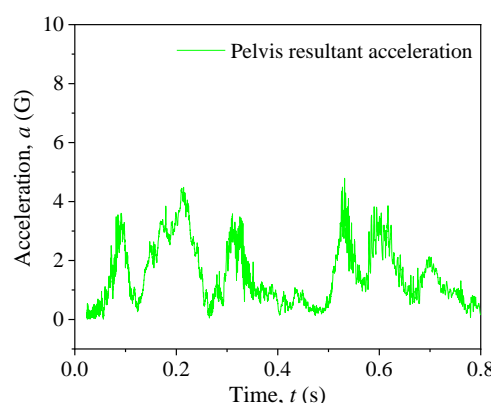
Table 4.20 Dummy responses and injury parameters for Category 2 – Case 2.

Dummy head acceleration	Head impact criteria

Head injury parameter	Value	Threshold	Pass/Fail
	HIC <sub>15</sub>	0.73	700	Pass
	$p(\text{HIC}_{15})$	0 %	31%	Pass
Dummy chest acceleration	Dummy pelvis acceleration

The simulation results of Category 2 – Case 2 were similar to those of the previous case with 0° impact angle. The mailbox upper body was separated from the pedestal upon impact and pushed forward by the vehicle. The damage on the vehicle was a V-shape dent on the hood due to impacting the corner mailbox. The trajectory of the mailbox showed that there was no possibility hitting the windshield of vehicle, eliminating the possibility of compartment intrusions. The vehicle's roll and pitch angles, as well as the OIVs and ORAs in both longitudinal and lateral directions, were all within the MASH allowed limits. During impact, the dummy's head moved forward but did not touch the deployed airbag. The maximum head acceleration was approximately 5 G and the HIC<sub>15</sub> value was calculated to be 0.73, far below the threshold value of 700 and indicating no possibility of skull injury. The above analysis indicated that there was no potential occupant injury for this impact case.

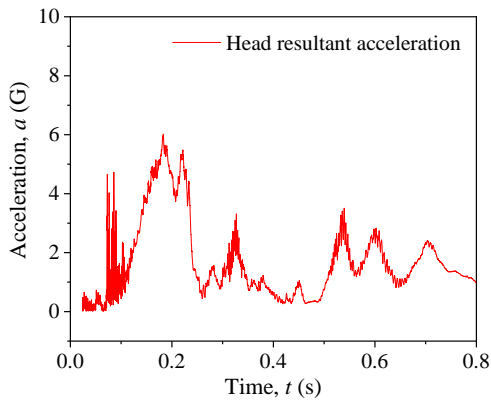
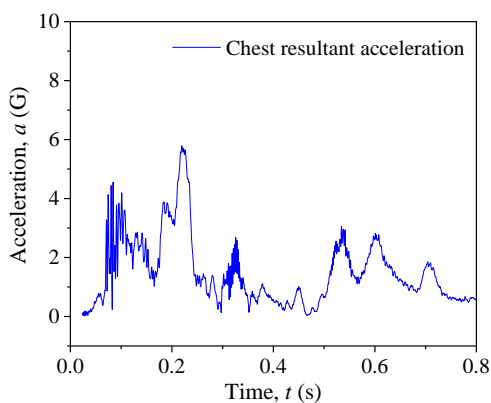
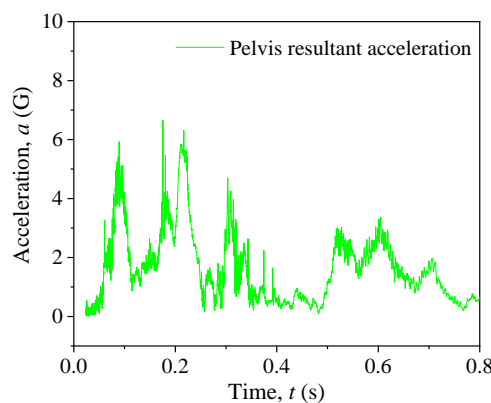
Table 4.22 Dummy responses and injury parameters for Category 2 – Case 3.

Dummy head acceleration		Head impact criteria

Head injury parameter	Value	Threshold	Pass/Fail
		HIC <sub>15</sub>	1.08	700	Pass
		$p(\text{HIC}_{15})$	0 %	31%	Pass
Dummy chest acceleration		Dummy pelvis acceleration

test dummy on the head, chest, and pelvis. The  $HIC_{15}$  and the probability of skull injury were also calculated for this case, as given in Table 4.22.

The simulation results of Category 2 – Case 3 showed that the upper bodies of both mailbox units were separated from the pedestals and pushed forward by the vehicle. The damage on the vehicle was only a large, flat dent on the hood with the hood partially popped up. The trajectory of the mailbox showed that there was no possibility for it to hit the windshield of vehicle, eliminating the possibility of compartment intrusions. The vehicle's roll and pitch angles, as well as the OIVs and ORAs in both longitudinal and lateral directions, were all within the MASH allowed limits. During impact, the dummy's head moved forward but did not touch the deployed airbag. The maximum head acceleration was approximately 6 G and the HIC<sub>15</sub> value was calculated to be 1.08, far below the threshold value of 700 and indicating no possibility of skull injury. The above analysis indicated that there was no potential occupant injury for this impact case.

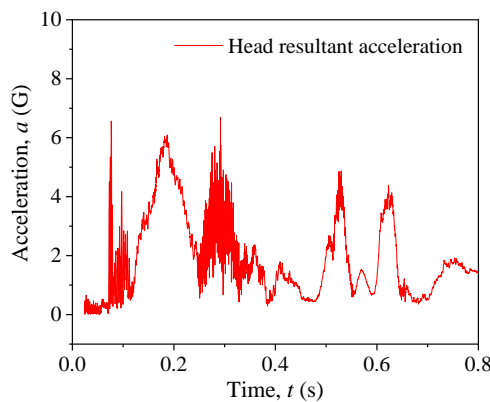
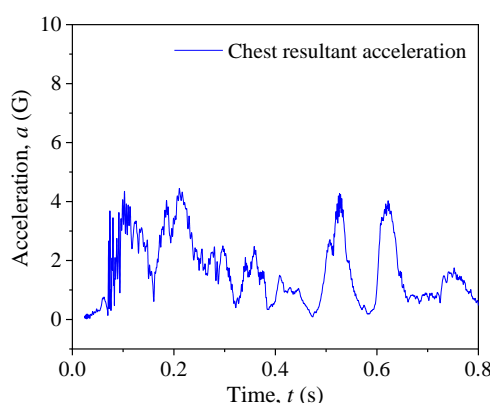
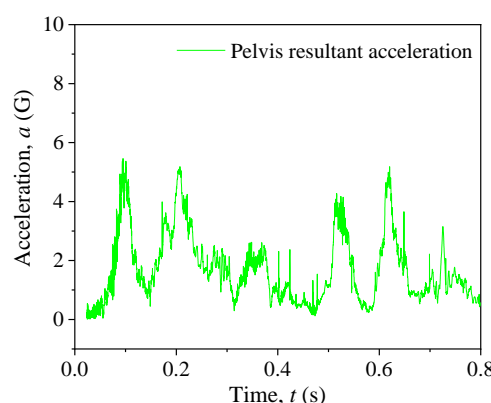
Table 4.24 Dummy responses and injury parameters for Category 2 – Case 4.

Dummy head acceleration	Head impact criteria

Head injury parameter	Value	Threshold	Pass/Fail
	HIC <sub>15</sub>	1.20	700	Pass
	$p(\text{HIC}_{15})$	0 %	31%	Pass
Dummy chest acceleration	Dummy pelvis acceleration

histories of the crash test dummy on the head, chest, and pelvis. The  $HIC_{15}$  and the probability of skull injury were also calculated for this case, as given in Table 4.24.

The simulation results of Category 2 – Case 4 showed that the connection between the pedestal and upper body of the unit being impacted first failed immediately, leaving the upper unit stuck between the vehicle's front and the second unit, which was pushed down to the ground. The wheel rolled over the pedestal of second mailbox while the upper body being pushed by the vehicle, resulting the failure of the connection. At the end of the crash, both mailbox units were pushed forward by the test vehicle. The damage on the vehicle was a sharp V-shape dent on the hood. The trajectory of the mailbox showed that there was no possibility of hitting the windshield of vehicle, eliminating the possibility of compartment intrusions. The vehicle's roll and pitch angles, as well as the OIVs and ORAs in both longitudinal and lateral directions, were all within the MASH allowed limits. For occupant response, the dummy's head moved forward for a long distance due to impact pulses, but it did not touch the deployed airbag. The maximum head acceleration was approximately 6 G and the HIC<sub>15</sub> value was calculated to be 1.20, far below the threshold value of 700 and indicating no possibility of skull injury. The above analysis indicated that there was no potential occupant injury for this impact case.

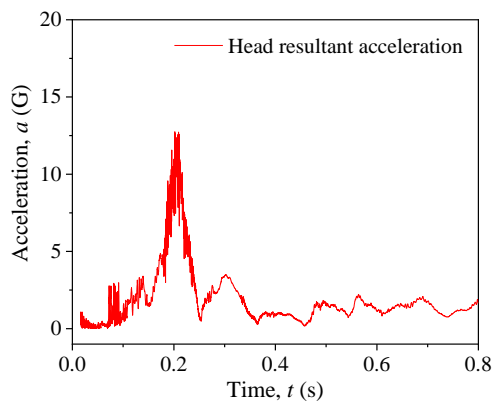
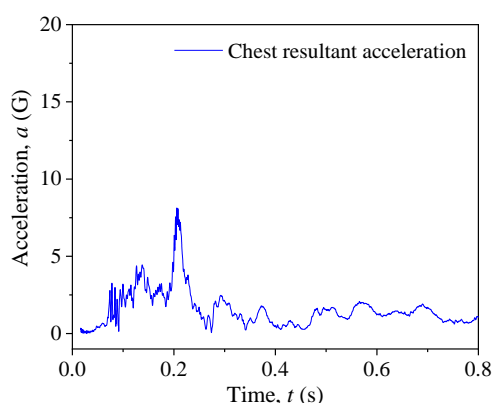
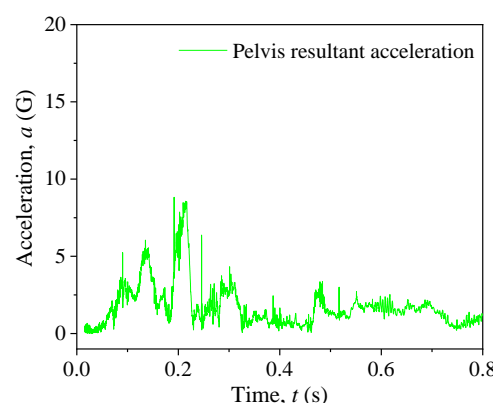
Table 4.26 Dummy responses and injury parameters for Category 2 – Case 5.

Dummy head acceleration	Head impact criteria

Head injury parameter	Value	Threshold	Pass/Fail
	HIC <sub>15</sub>	5.16	700	Pass
	$p(\text{HIC}_{15})$	0 %	31%	Pass
Dummy chest acceleration	Dummy pelvis acceleration

model before impact and the deformed vehicle model after impact. Figure 4.26 shows the overlapping contour plot of vehicle trajectory for this case. The vehicle's roll and pitch angles, OIVs, and ORAs were calculated and summarized in Table 4.25. Table 4.26 gives the acceleration histories of the crash test dummy on the head, chest, and pelvis. The HIC<sub>15</sub> and the probability of skull injury were also calculated for this case, as given in Table 4.26.

The simulation results of Category 2 – Case 5 showed that mailbox unit impacted first by the vehicle remained attached to the ground while the second unit was separated from the ground and pushed forward along the vehicle’s travel direction. The damage on the vehicle was a dent around the front right corner of the hood. The trajectory of the mailbox showed that there was no possibility of hitting the windshield of vehicle, eliminating the possibility of compartment intrusions. The vehicle’s roll and pitch angles, as well as the OIVs and ORAs in both longitudinal and lateral directions, were all within the MASH allowed limits. For occupant response, the dummy’s head did not touch the deployed airbag and the maximum head acceleration was approximately 12.5 G. The HIC<sub>15</sub> value was calculated to be 5.16, which was far below the threshold value of 700 and indicating no possibility of skull injury. The above analysis indicated that there was no potential occupant injury for this impact case.

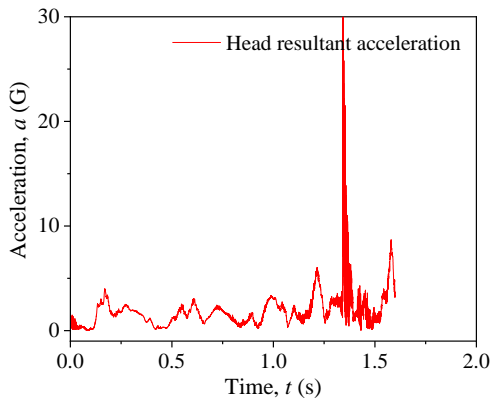
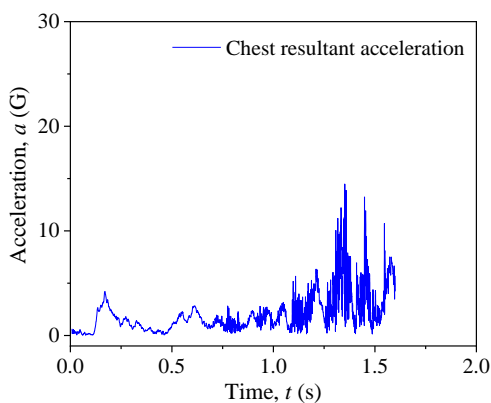
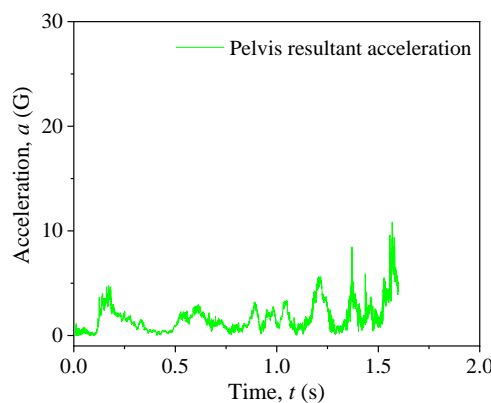
Table 4.28 Dummy responses and injury parameters for Category 2 – Case 6.

Dummy head acceleration		Head impact criteria

Head injury parameter	Value	Threshold	Pass/Fail
		HIC <sub>15</sub>	8.98	700	Pass
		$p(\text{HIC}_{15})$	0 %	31%	Pass
Dummy chest acceleration		Dummy pelvis acceleration

The simulation results of Category 2 – Case 6 showed that the connection of the mailbox to the ground failed quickly upon impact and the mailbox was pushed forward with the pedestal still connected with the upper body. The damage on the vehicle was limit to the front, with a deep V-shape dent on hood. The trajectory of the mailbox showed that there was no possibility of hitting the windshield of vehicle, eliminating the possibility of compartment intrusions. The vehicle's roll and pitch angles, as well as the OIVs and ORAs in both longitudinal and lateral directions, were all within the MASH allowed limits. During impact, the dummy's head moved forward but did not touch the deployed airbag. It should be noted that there was a large peak acceleration at approximately 1.3 second on the dummy head. Upon analysis of the dummy's responses and accelerations at the chest and pelvis, the peak head acceleration was deemed to be a numerical noise and should not be considered as a safety issue. The HIC<sub>15</sub> value was calculated to be 8.98, far below the threshold value of 700 and indicating no possibility of skull injury. The above analysis indicated that there was no potential occupant injury for this impact case.

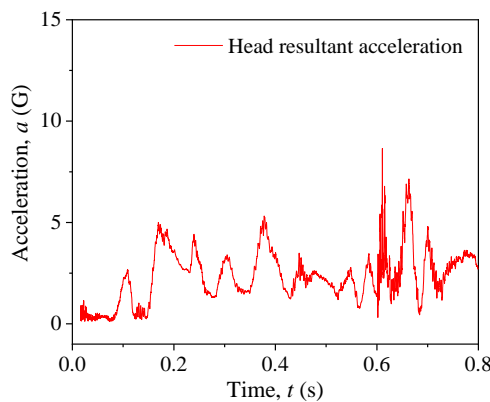
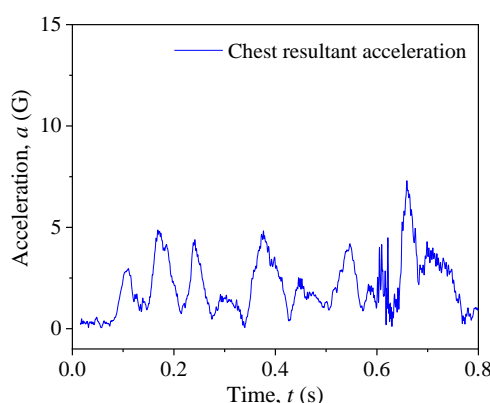
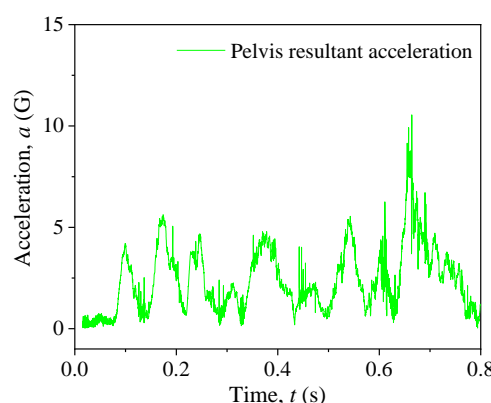
Table 4.30 Dummy responses and injury parameters for Category 2 – Case 7.

Dummy head acceleration	Head impact criteria

Head injury parameter	Value	Threshold	Pass/Fail
	HIC <sub>15</sub>	1.36	700	Pass
	$p(\text{HIC}_{15})$	0 %	31%	Pass
Dummy chest acceleration	Dummy pelvis acceleration

the overlapping contour plot of vehicle trajectory for this case. The vehicle's roll and pitch angles, OIVs, and ORAs were calculated and summarized in Table 4.29. Table 4.30 gives the acceleration histories of the crash test dummy on the head, chest, and pelvis. The HIC<sub>15</sub> and the probability of skull injury were also calculated for this case, as given in Table 4.30.

The simulation results of Category 2 – Case 7 showed that the mailbox unit being impacted first was quickly detached from the ground, with its upper body stuck between the vehicle and the second mailbox unit. The second mailbox unit was subsequently pushed down to the ground and the upper body was separated from the pedestal due to dragging and ripping effects. There were severe warpages and wrinkles on the front of the first mailbox unit. The damage on the vehicle was a V-shape dent on hood, which was slightly popped open. The trajectory of the mailbox showed that there was no possibility for it to hit the windshield of vehicle, eliminating the possibility of compartment intrusions. The vehicle's roll and pitch angles, as well as the OIVs and ORAs in both longitudinal and lateral directions, were all within the MASH allowed limits. For occupant response, the dummy's head moved forward but did not touch the deployed airbag. The HIC<sub>15</sub> value was calculated to be 1.36, far below the threshold value of 700 and indicating no possibility of skull injury. The above analysis indicated that there was no potential occupant injury for this impact case.

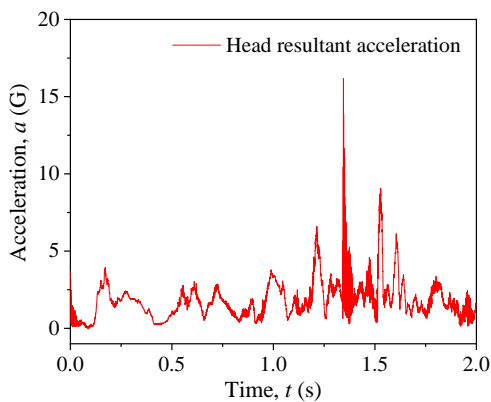
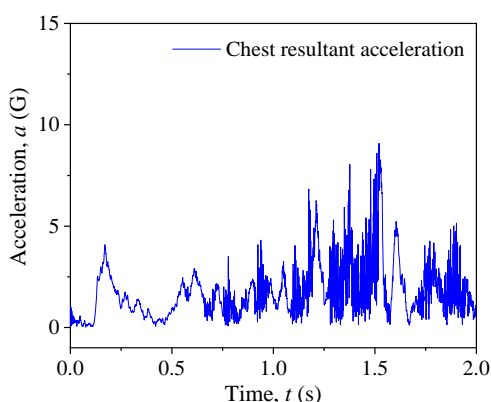
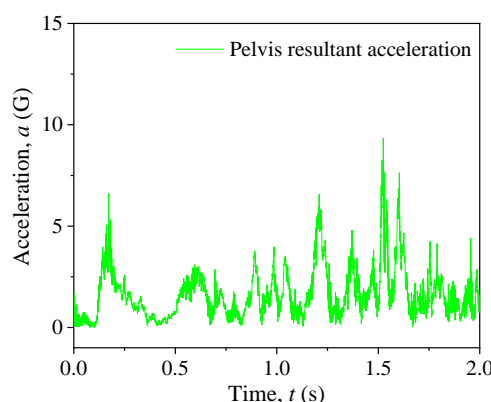
Table 4.32 Dummy responses and injury parameters for Category 2 – Case 8.

Dummy head acceleration		Head impact criteria

Head injury parameter	Value	Threshold	Pass/Fail
		HIC <sub>15</sub>	2.55	700	Pass
		$p(\text{HIC}_{15})$	0 %	31%	Pass
Dummy chest acceleration		Dummy pelvis acceleration

shows the overlapping contour plot of vehicle trajectory for this case. The vehicle's roll and pitch angles, OIVs, and ORAs were calculated and summarized in Table 4.31. Table 4.32 gives the acceleration histories of the crash test dummy on the head, chest, and pelvis. The  $HIC_{15}$  and the probability of skull injury were also calculated for this case, as given in Table 4.32.

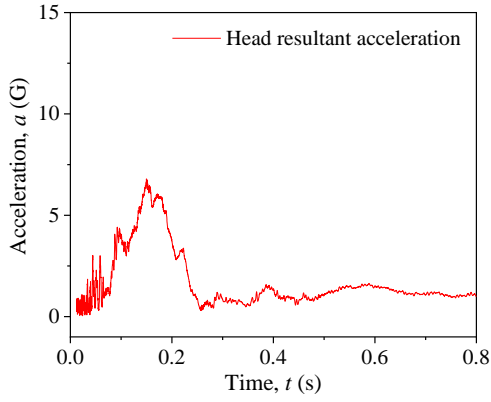
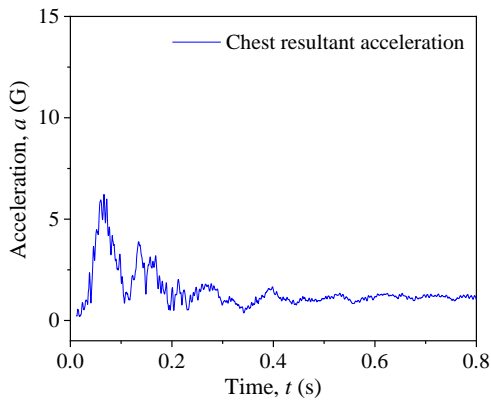
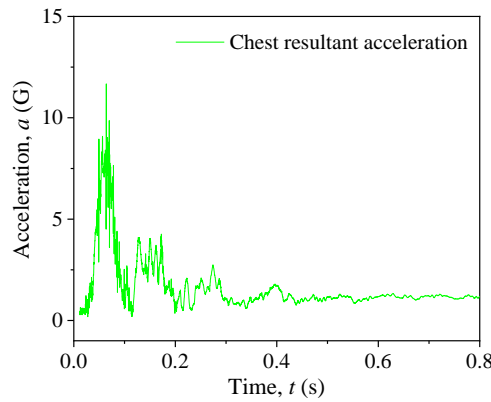
Table 4.34 Dummy responses and injury parameters for Category 3 – Case 1.

Dummy head acceleration		Head impact criteria

Head injury parameter	Value	Threshold	Pass/Fail
		HIC <sub>15</sub>	1.52	700	Pass
		<i>p</i> (HIC <sub>15</sub> )	0 %	31%	Pass
Dummy chest acceleration		Dummy pelvis acceleration

The simulation results of Category 3 – Case 1 showed that the pedestal was separated from the upper body upon impact and stuck under the chassis of the Yaris. The upper body was pushed forward by the vehicle and caused minor damage to the front bumper and hood of the vehicle. The trajectory of the mailbox showed that there was no possibility of hitting the windshield of vehicle, eliminating the possibility of compartment intrusions. The vehicle's roll and pitch angles, as well as the OIVs and ORAs in both longitudinal and lateral directions, were all within the MASH allowed limits. The dummy's head moved forward and barely touched the deployed airbag. The HIC<sub>15</sub> value was calculated to be 1.52, far below the threshold value of 700 and indicating no possibility of skull injury. The above analysis indicated that there was no potential occupant injury for this impact case.

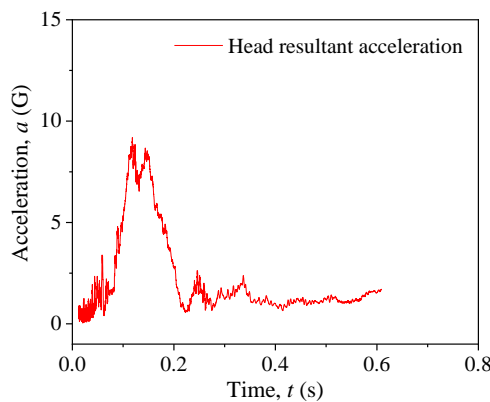
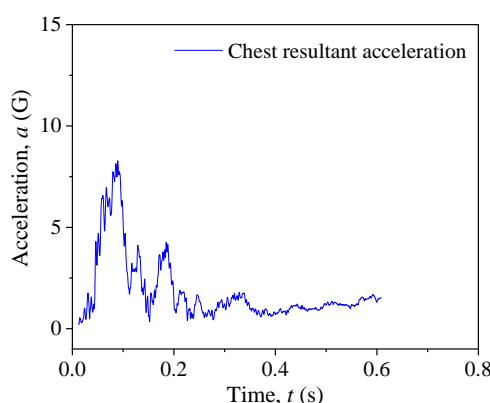
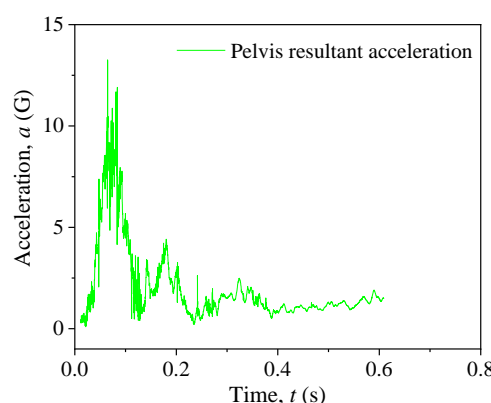
Table 4.36 Dummy responses and injury parameters for Category 3 – Case 2.

Dummy head acceleration	Head impact criteria

Head injury parameter	Value	Threshold	Pass/Fail
	HIC <sub>15</sub>	2.99	700	Pass
	$p(\text{HIC}_{15})$	0 %	31%	Pass
Dummy chest acceleration	Dummy pelvis acceleration

The simulation results of Category 3 – Case 2 was similar to the results of Category 3 – Case 1 in terms of mailbox failure and trajectory as well as vehicle damages. The vehicle's roll and pitch angles, as well as the OIVs and ORAs in both longitudinal and lateral directions, were all within the MASH allowed limits. similar as the last case. During impact, the dummy's head moved forward and slightly touched the deployed airbag. The maximum head acceleration was approximately 9 G and the HIC<sub>15</sub> value was calculated to be 2.99, far below the threshold value of 700 and indicating no possibility of skull injury. The above analysis indicated that there was no potential occupant injury for this impact case.

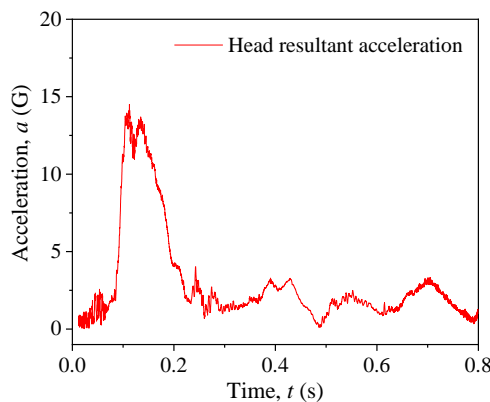
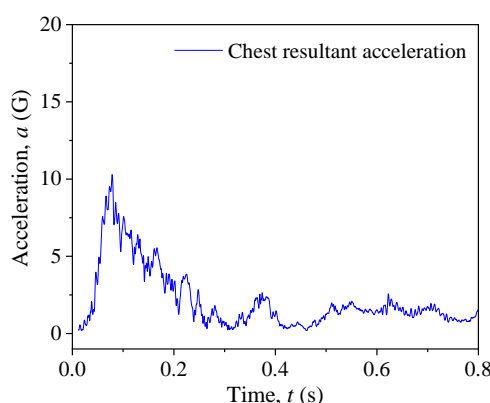
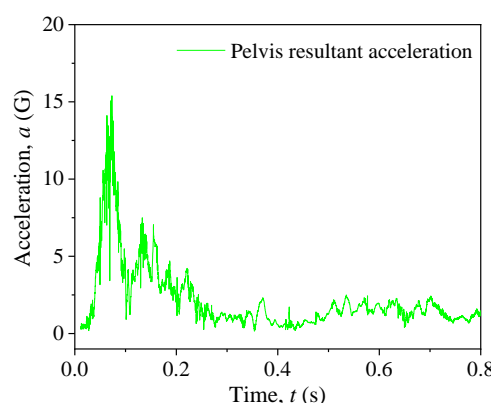
Table 4.38 Dummy responses and injury parameters for Category 3 – Case 3.

Dummy head acceleration		Head impact criteria

Head injury parameter	Value	Threshold	Pass/Fail	
	HIC <sub>15</sub>	9.70	700	Pass	
	$p(\text{HIC}_{15})$	0 %	31%	Pass	
Dummy chest acceleration		Dummy pelvis acceleration

The simulation results of Category 3 – Case 3 showed that the pedestals of both units were separated from the upper bodies upon impacts of the vehicle. Both upper units were pushed forward by the vehicle, with the unit impacted first severely damaged. The larger mass of the Type IV mailbox caused larger damage on the vehicle's front than that for the Type I mailbox. The trajectory of the mailbox showed that there was no possibility of hitting the windshield of vehicle, eliminating the possibility of compartment intrusions. The vehicle's roll and pitch angles, as well as the OIVs and ORAs in both longitudinal and lateral directions, were all within the MASH allowed limits. During impact, the dummy's head moved forward and hit the deployed airbag. The maximum head acceleration was approximately 14 G and the HIC<sub>15</sub> value was calculated to be 9.70, far below the threshold value of 700 and indicating no possibility of skull injury. The above analysis indicated that there was no potential occupant injury for this impact case.

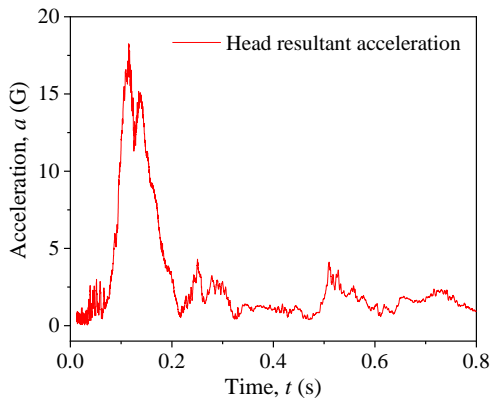
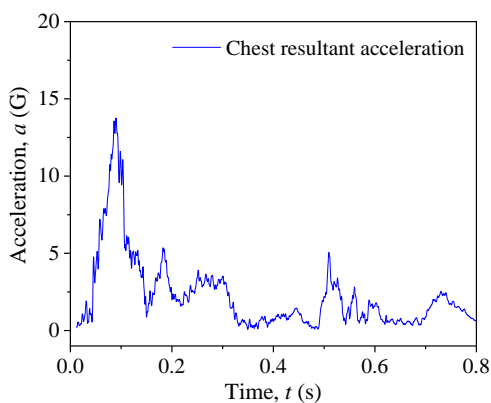
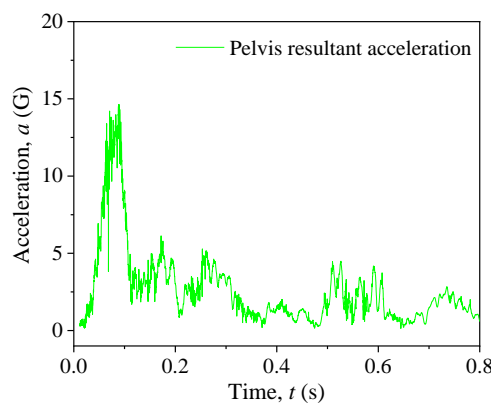
Table 4.40 Dummy responses and injury parameters for Category 3 – Case 4.

Dummy head acceleration		Head impact criteria

Head injury parameter	Value	Threshold	Pass/Fail
		HIC <sub>15</sub>	15.89	700	Pass
		$p(\text{HIC}_{15})$	0 %	31%	Pass
Dummy chest acceleration		Dummy pelvis acceleration

The simulation results of Category 3 – Case 4 were similar to those of Case 3 in terms of mailbox failures and vehicle damage. The two upper units were pushed forward by the vehicle and the trajectory of the mailbox indicated no possibility of hitting the windshield of vehicle, eliminating the possibility of compartment intrusions. The vehicle's roll and pitch angles, as well as the OIVs and ORAs in both longitudinal and lateral directions, were all within the MASH allowed limits. In this case, the dummy's head moved forward and hit the deployed airbag. The maximum head acceleration was approximately 18 G and the HIC<sub>15</sub> value was calculated to be 15.89, far below the threshold value of 700 and indicating no possibility of skull injury. The above analysis indicated that there was no potential occupant injury for this impact case.
